STOREFRONTS

OVERVIEW

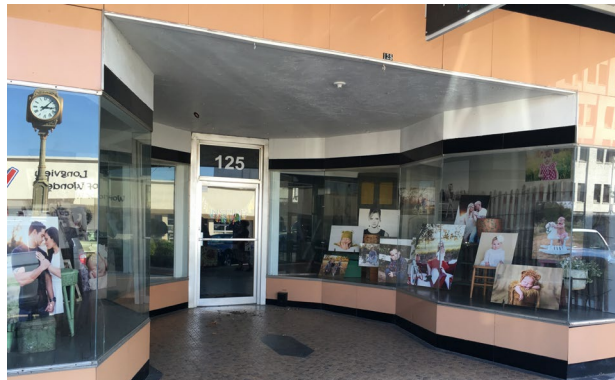
Above: Longview, Texas. Modernized historic storefront with recessed entry, aluminum display windows, and clad in structural glass. The tile entry also remains in place.

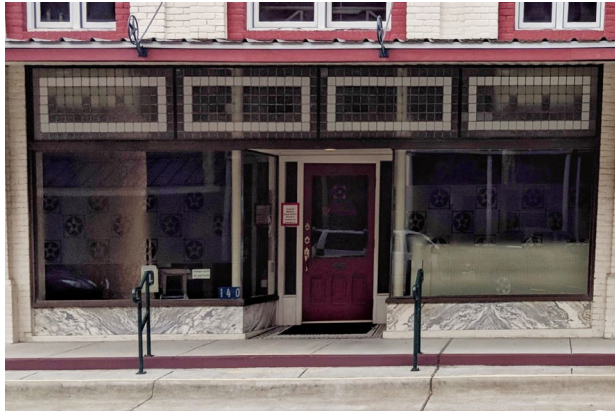
Above: La Grange, Texas. Copper storefront example (1900-1930s).

Metal was used for the frame and even in some cases, to hold in the sash. The wood bulkhead panels were replaced with stone, brick, metal, and marble, similar to the example shown above. The use of copper and bronze in storefront design was short lived due to the introduction of an inexpensive alternative, aluminum. This transformation began in the 1930s, but it was interrupted by World War II. Notably, copper and bronze storefronts did not disappear completely. High-end department stores and construction projects with a more flexible budget, incorporated these storefronts. While both types of metals were more modern in appearance than wood storefronts, the copper and bronze frames maintained a certain level of traditional detail. The early metal frames had curves and rounded profiles that added shadow and depth to the overall appearance. By the Mid-Century, technological advancements in materials

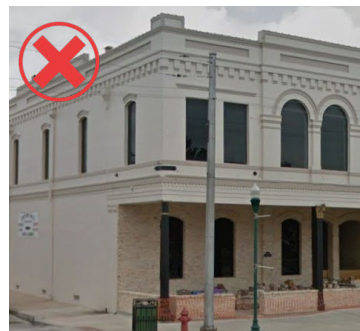
STOREFRONT WITH CONTEMPORARY MATERIALS

- A cornice is made with metal over a wooden frame.
- Optional transoms can be clear or frosted glass.
- Masonry piers coordinate with the upper facade.
- Storefront is recessed 6 inches into the opening.
- Storefront is framed with anodized or treated wood with a finish that coordinates with the overall color scheme or existing materials of the building.
- The storefront framing rests on masonry or concrete base.

Above: Illustration shown is from the *Keeping Up Appearances for Storefronts Guide*, created by the National Trust for Historic Preservation.

Left: Over time, the building has been significantly altered from its original design. The new design, shown on the right of the historic photograph, is a trend that does not take into consideration any historic documentation, proportions to adjacent structures, scale, nor does it maintain the historic planar relationship of the upper facade. Instead of recessing an entire storefront to create a hollowed-out space for outdoor seating, consider other alternatives, such as concentrating seating areas to the sidewalk if there is a sufficient amount of space, or consider parklets. Always consult with your Authority Having Jurisdiction, before proceeding with these alternatives.

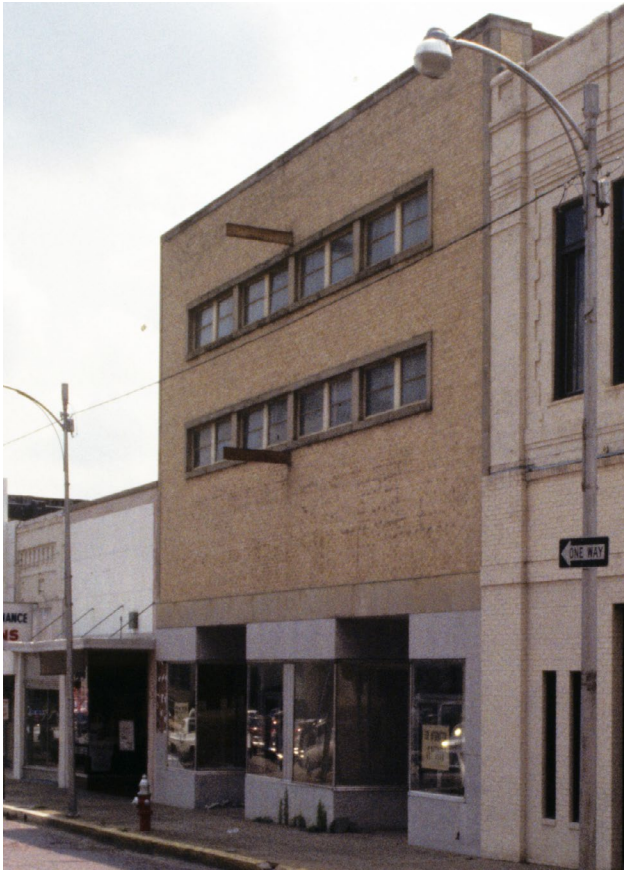
Above: Before rehabilitation. Tyler, Texas in 1981.

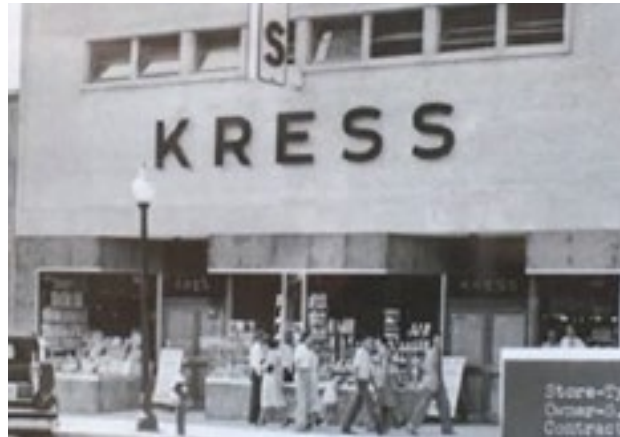
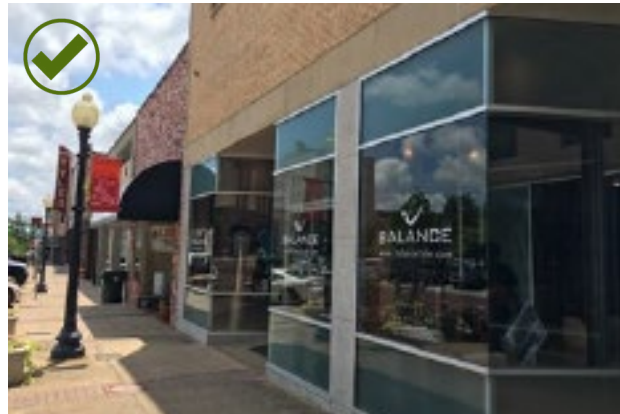
This rehabilitation project to a Kress Department Store in Tyler, Texas is an example of a new storefront design that takes inspiration from the historic storefront. Constructed of modern materials, the new storefront aligns with the proportions seen in the original design, and recessed door layout using a contemporary anodized aluminum storefront system with a thin profile. The new design incorporates the historic

configuration, while also substituting the material with a compatible solution that conveys the same transparency and opacity in the original design. This historic photo provides a clear view of the modernized storefront proportions with the large display windows. In this case, the replacement was appropriate, since the storefront was severely deteriorated and beyond repair.
